LABORATORY AND FIELD INVESTIGATIONS
EXAMINING
THE INHIBITION OF
ACID GENERATION FROM PYRITIC MATERIALS

PERD COAL WASTE ROCK PILES
FIELD OBSERVATIONS AND REPORT

Fred Baechler

RE: Investigation of Perd Piles at CBDC's VJCPP

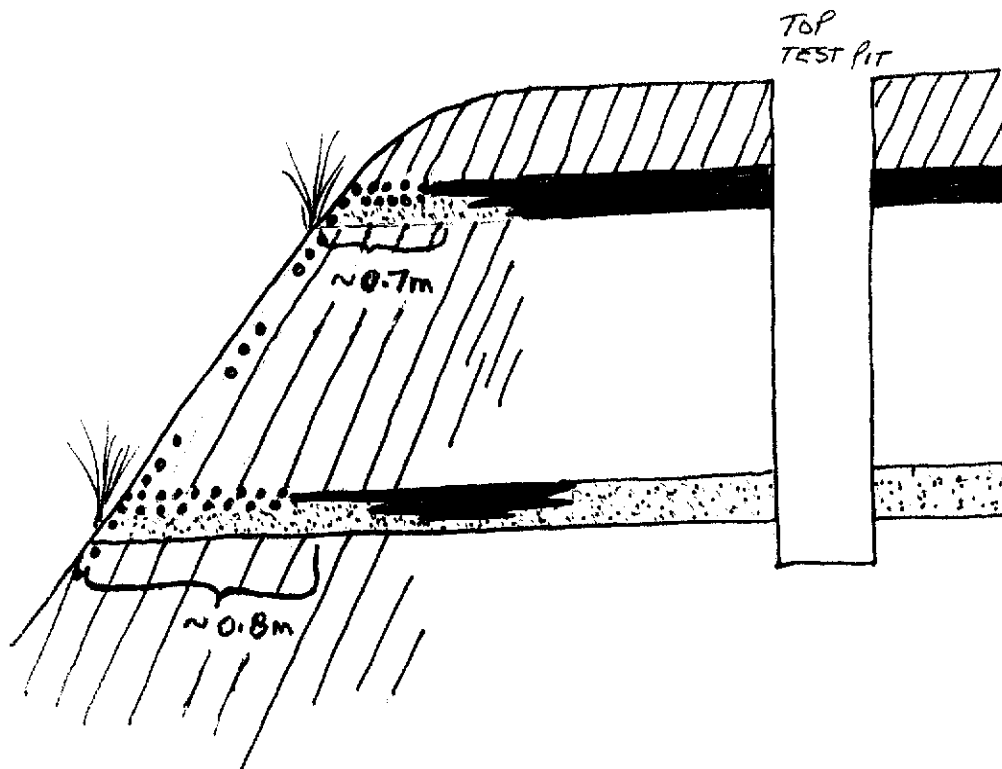
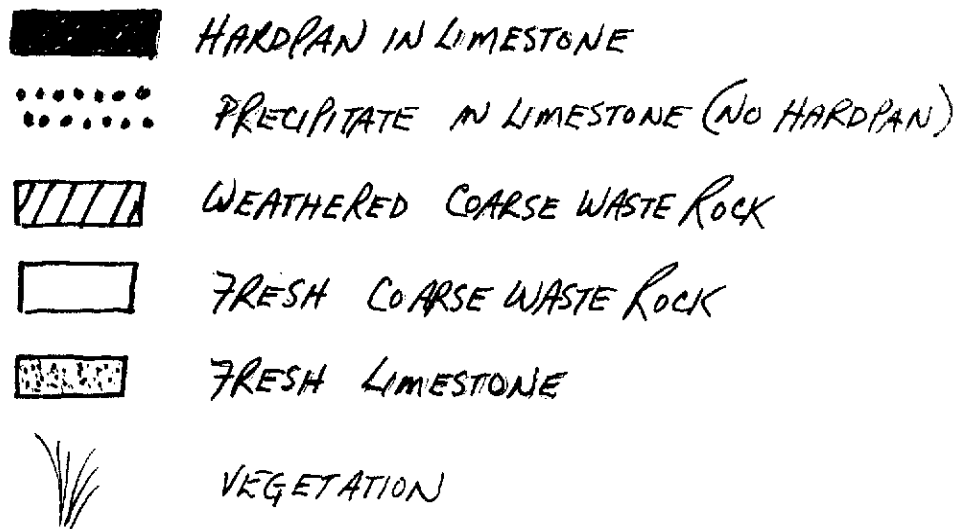
The diagram below best summarizes the findings from the trench. The trench was damp; no saturated conditions or smells were encountered. The main points of note include:

- 1) A loose, "dark red brown", precipitate layer was present parallel to and within 10 cm of the surface, probably resulting from the thin layer of limestone spread over the surface. This was less than 5 cm thick but had not been fully cemented into a hardpan, possibly due to the very thin amount of coarse waste above it for acid generation.

- 3) The second limestone hardpan exhibited a thin (1-4 cm) zone of wet coarse waste with "yellow" precipitate immediately above the hardpan. This would denote perched water table conditions, with seepage directed laterally out to the interflow zone and then to the surface drains; thereby, directing flow away from the underdrains. This would explain the absence of underdrain flow for such a long time in this pile and its initial high pH. It could also explain the whitish precipitate halos around some of the vegetation; this, being a result of the evaporation of slow moving groundwater seepage perched over the hardpans as it discharged at surface. Such drainage would probably be of an elevated pH and would aid in the establishment of the vegetation.

- 4) The interflow zone on this pile is therefore disrupted by perched water tables associated with the limestone hardpan. However, these lateral

hardpan layers will not extend deep into the core of the pile as noted from the surface test pit.

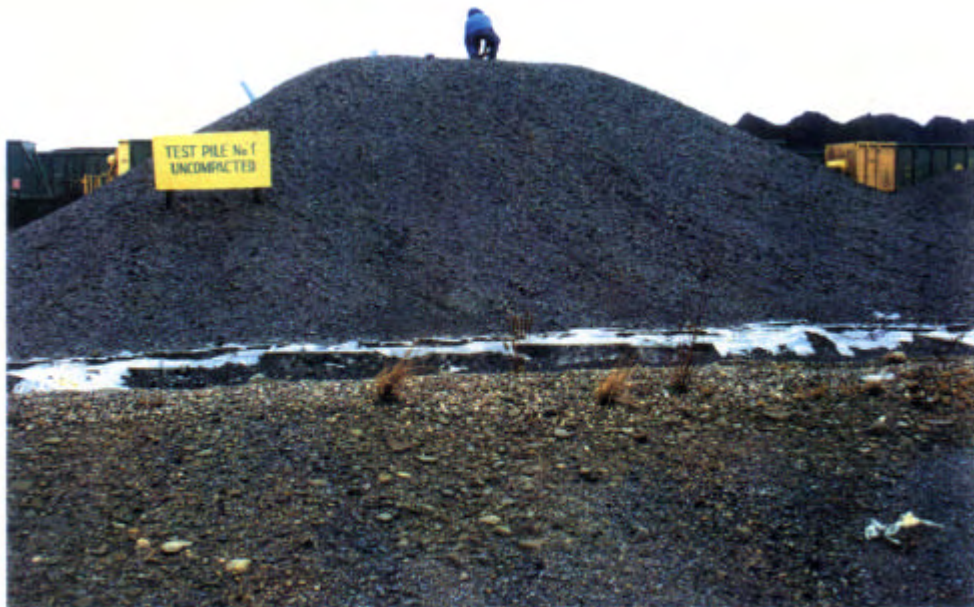
Plate 2: PERD Pile 1, Uncompacted, No Amendment, November 11-13, 1996. Overview, south facing slope.

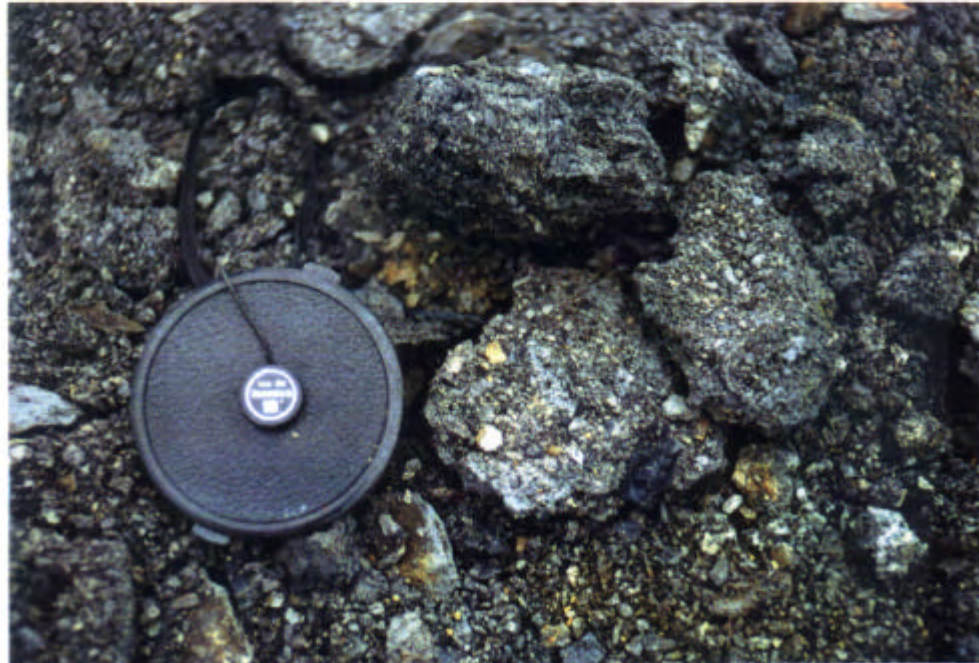
Plate 5: PERD Pile 1, Uncompacted, No Amendment, November 11-13, 1996.
Surface crust.

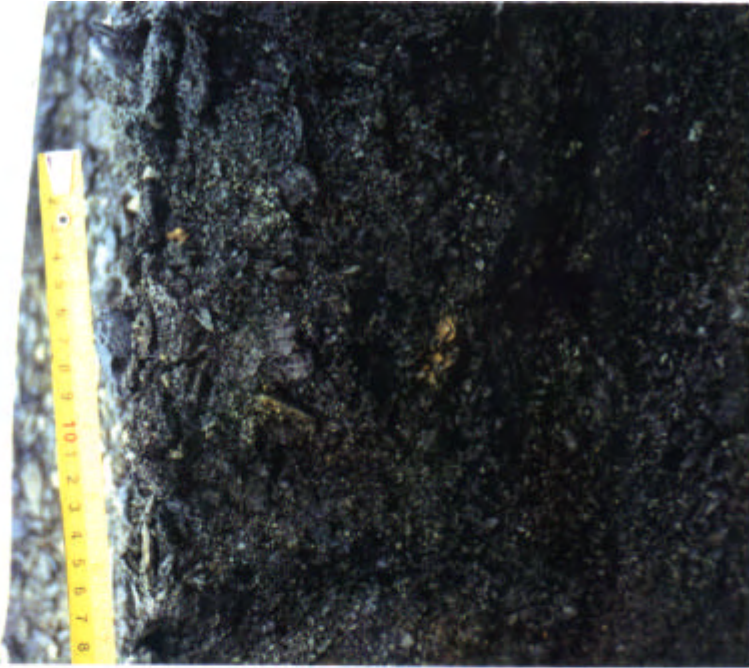
Plate 6: PERD Pile 1, Uncompacted, No Amendment, November 11-13, 1996.
First pit over top.

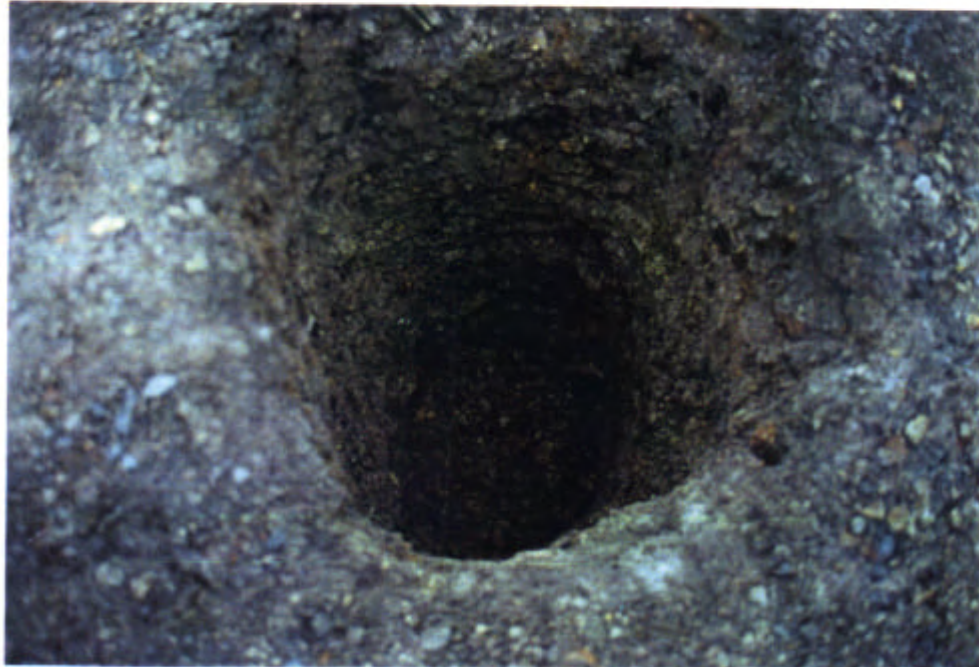
Plate 7: PERD Pile 1, Uncompacted, No Amendment, November 11-13, 1996.
First pit over top.

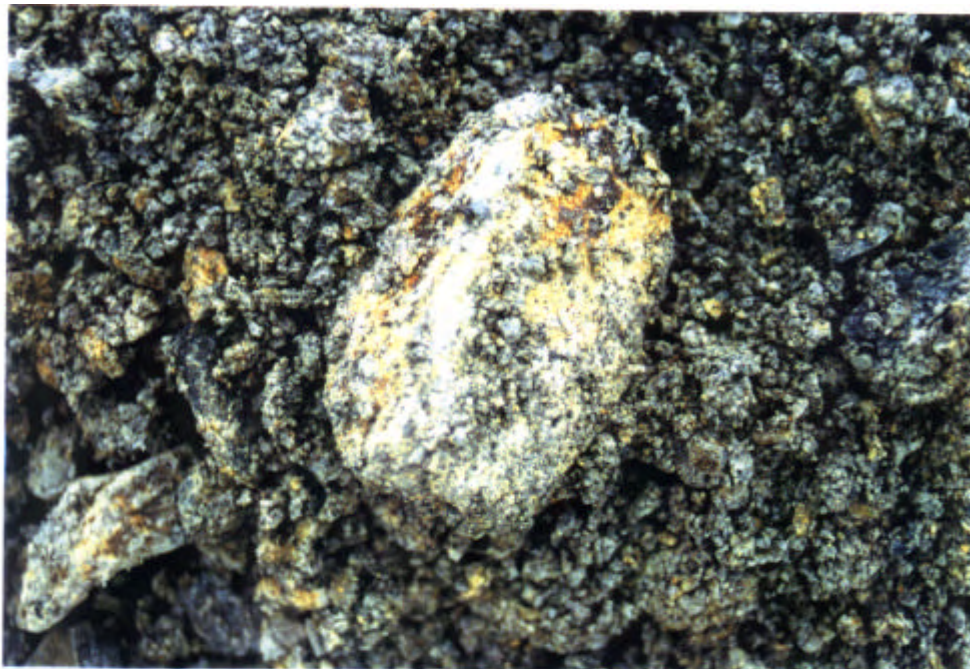
Plate 8: PERD Pile 1, Uncompacted, No Amendment, November 11-13, 1996.
Staining on clasts out of pit 1.

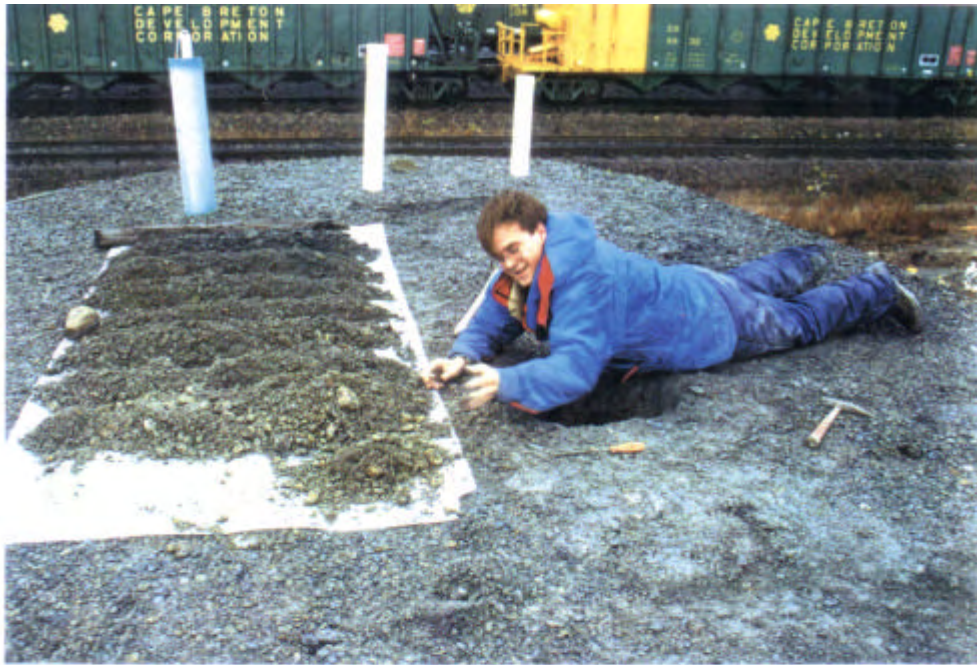
Plate 10: PERD Pile 1, Uncompacted, No Amendment, November 11-13, 1996. Pit 1 materials after completion of pit 1 excavation.

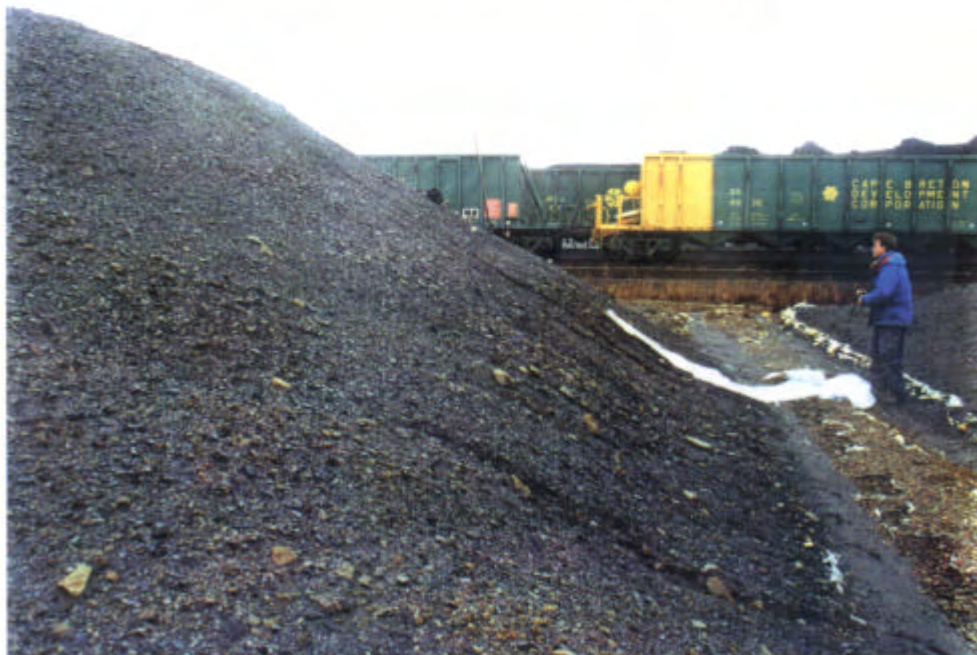
Plate 11: PERD Pile 1, Uncompacted, No Amendment, November 11-13, 1996. E facing side slope where side pits dug.

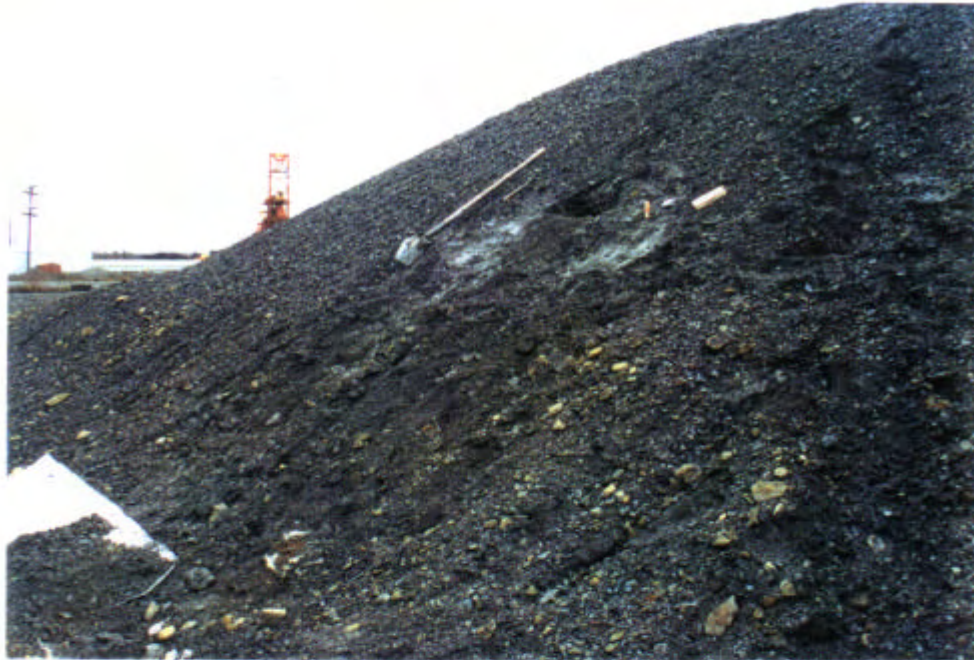
At mid-slope a 0.85 m deep hole excavated into the base of a shallow rill revealed a lag pavement over the surface (no staining on the clasts), but no crust. This was underlain by a 0.4 m zone exhibiting the loose, grey, coarse waste noted above with the "yellow" precipitate on the clasts. This zone exhibited a base which generally ran parallel to the surface slope. This was underlain by a "grey" coarse waste with minor precipitate on scattered clasts. This 0.4 m thick zone is expected to represent the Interflow zone noted in the conceptual model, where surface runoff infiltrates into the shallow subsurface along the side slopes then moves quickly down slope to enter the surface perimeter ditches, creating the strong acid component at later stages in the storm hydrographs.

Plate 12: PERD Pile 1, Uncompacted, No Amendment, November 11-13, 1996
Mid slope pit.

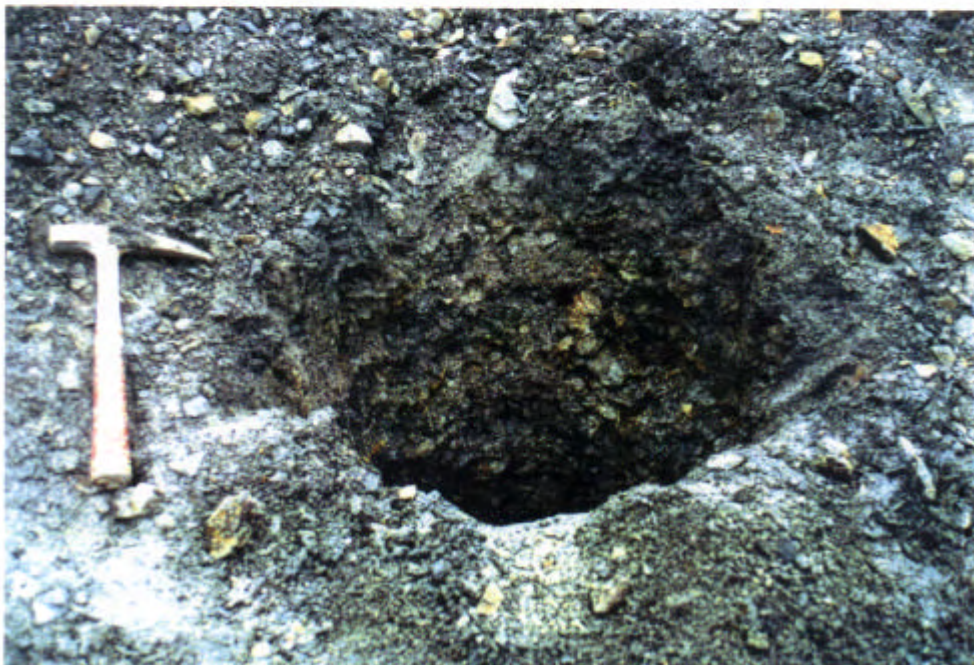
Plate 13: PERD Pile 1, Uncompacted, No Amendment, November 11-13, 1996
Close up of mid slope pit.

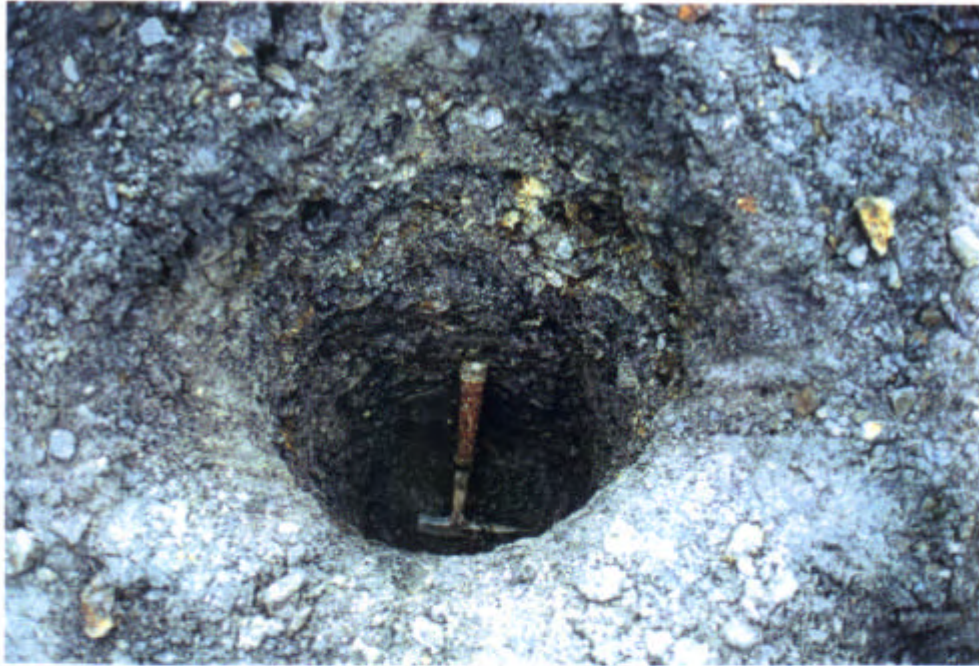
Plate 14: PERD Pile 1, Uncompacted, No Amendment, November 11-13, 1996.
Mid slope pit.

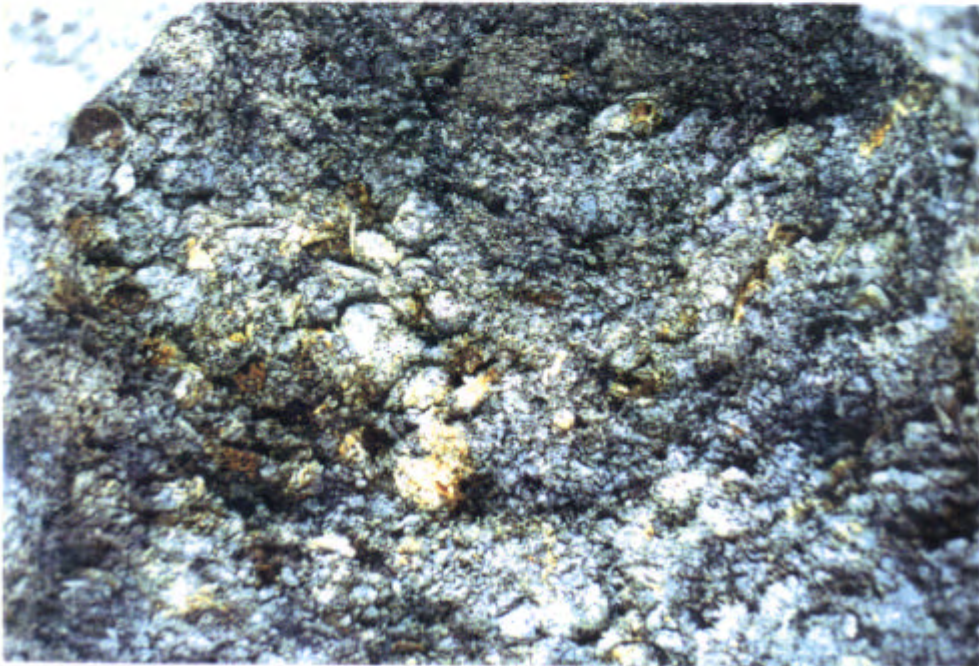
Plate 15: PERD Pile 1, Uncompacted, No Amendment, November 11-13, 1996.
Mid slope pit. Close-up of staining near surface.

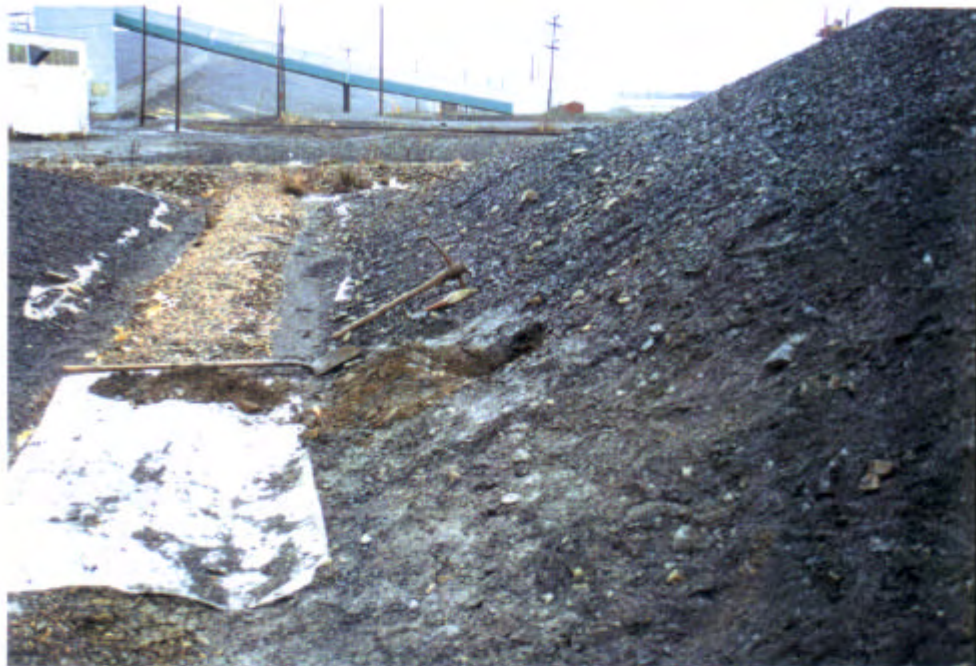
At the toe-of-slope one pit positioned along the east side wall noted a 5 cm thick "dark red" (dark reddish brown 10R3/4 to very dark red 5R2/6) precipitate zone developed in the underlying till immediately over the plastic liner keyed into the side wall, that underlies the surface perimeter drain. At the northeast corner, where seepage had been noted during rainfall events, a loose 4-8 cm thick heavily "yellow" stained zone was noted in the coarse waste directly over the till liner; a hardpan was not developed.

Plate 16: PERD Pile 1, Uncompacted, No Amendment, November 11-13, 1996.
Toe of slope pit.

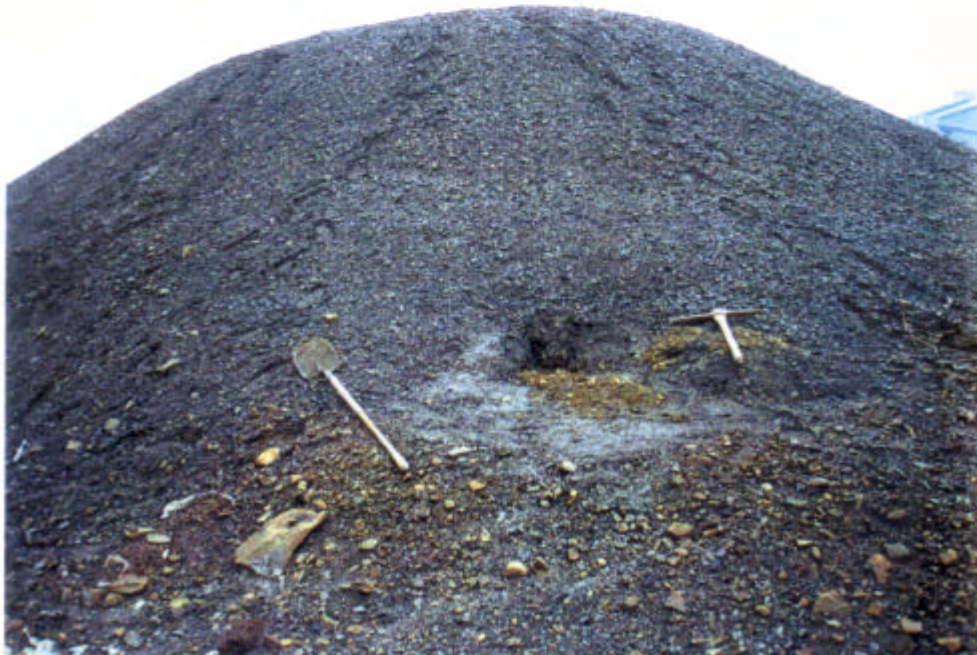
Plate 19: PERD Pile 1, Uncompacted, No Amendment, November 11-13, 1996.
Toe of slope pit at N-E corner just above surface staining.

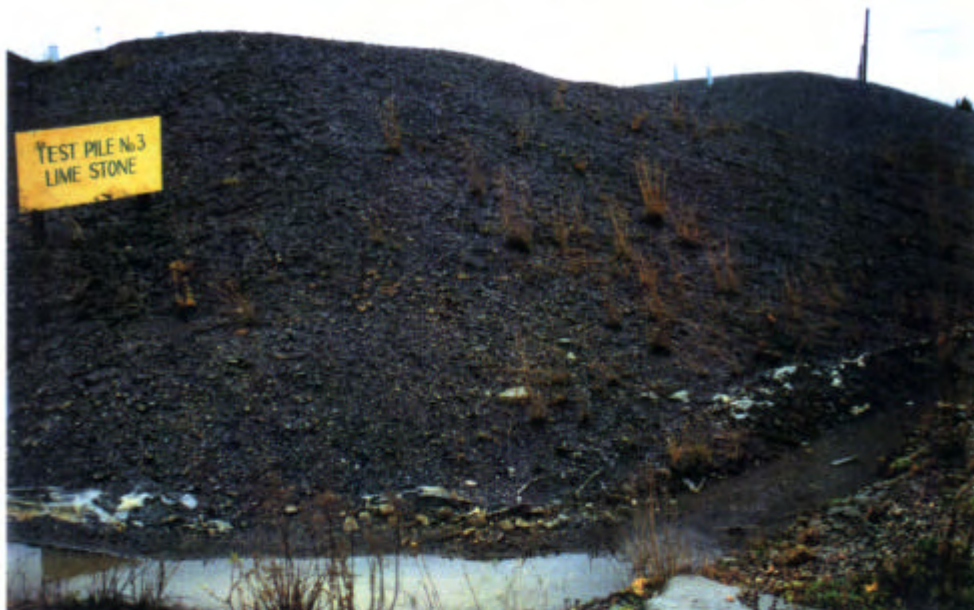
Plate 21: PERD Pile 3, Compacted, Limestone Amended, November 11-13, 1996. Overview of S facing slope.

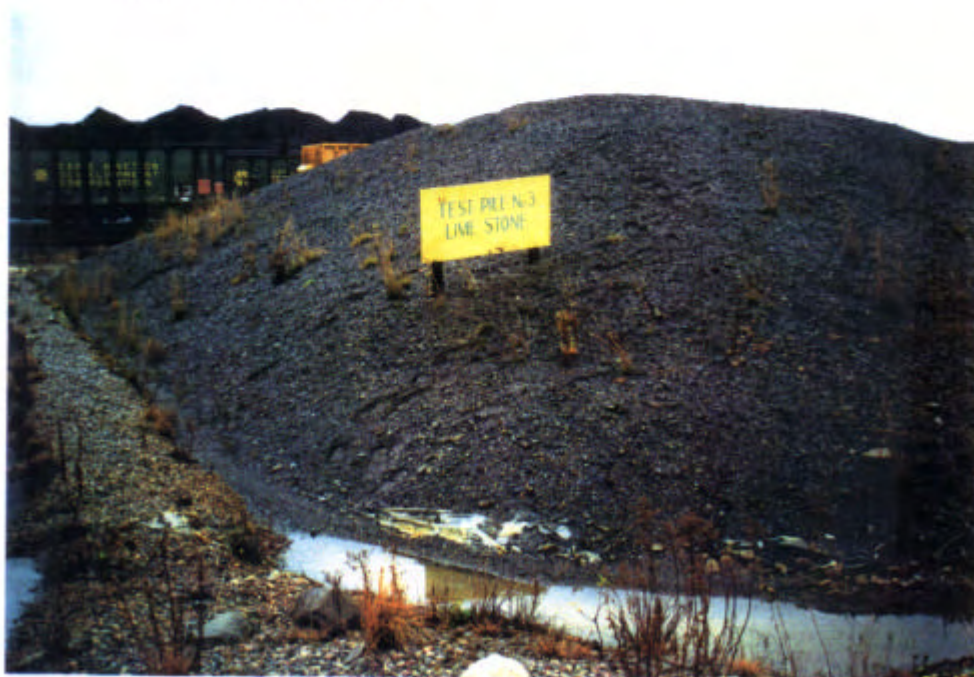
Plate 22: PERD Pile 3, Compacted, Limestone Amended, November 11-13, 1996. Overview of W facing slope.

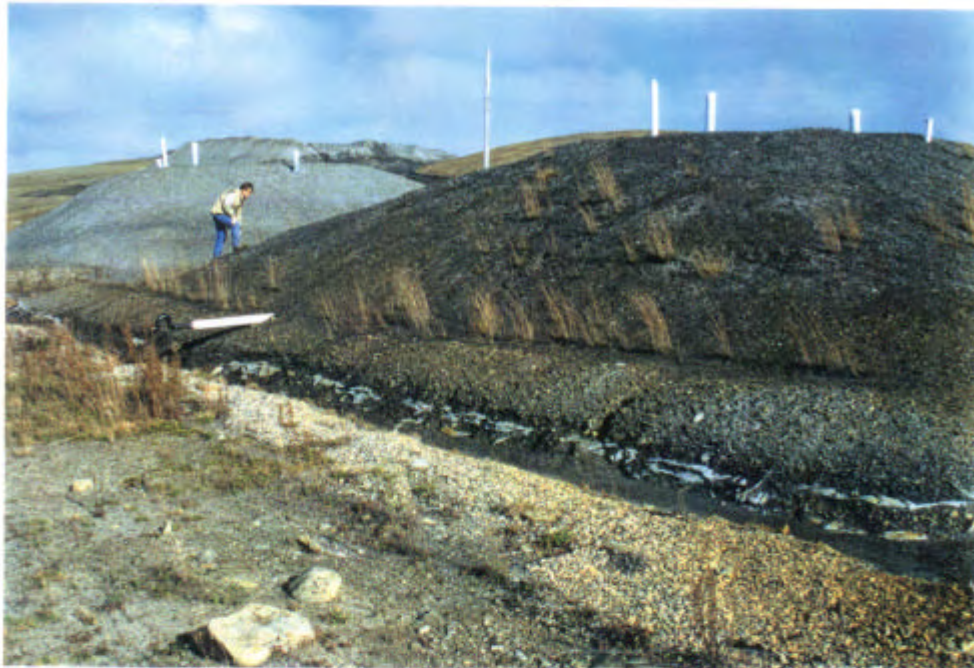
Plate 23: PERD Pile 3, Compacted, Limestone Amended, November 11-13, 1996. Overview of N facing slope.

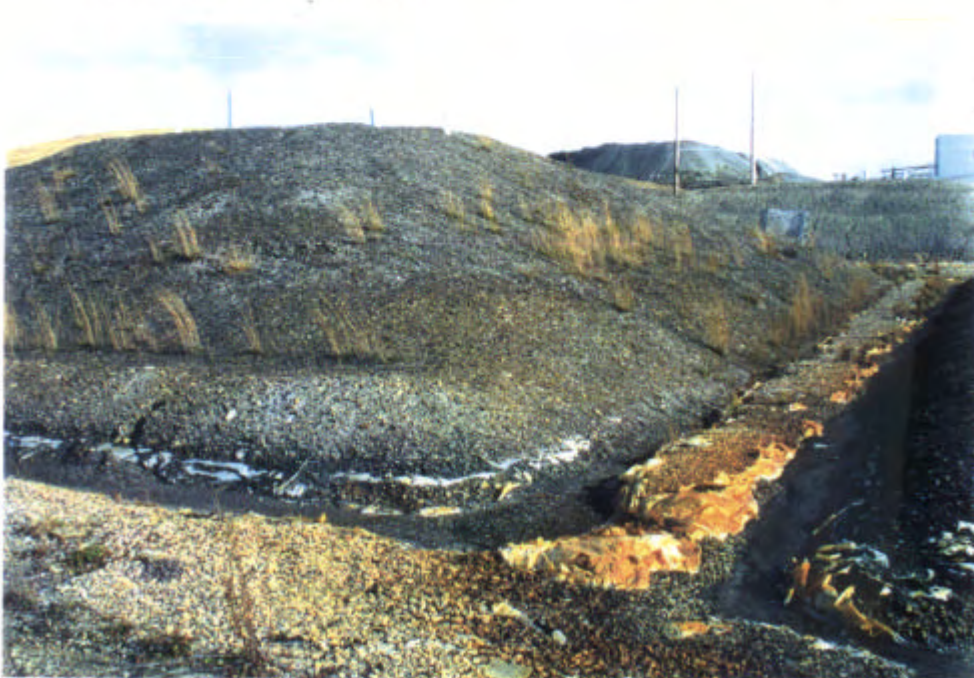
Plate 24: PERD Pile 3, Compacted, Limestone Amended, November 11-13, 1996. Overview of N-W corner.

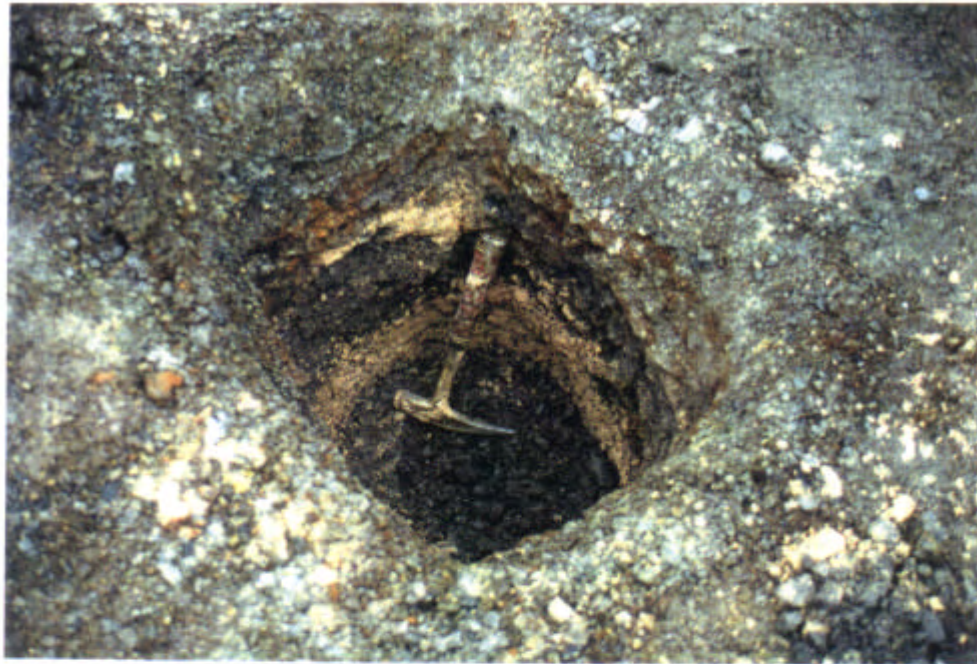
- *Test Pit on Top of the Pile:*
One 0.3 x 0.6 m pit was excavated by hand to a depth of approximately 0.7 m (25% of the total depth of the pile). From the surface down to the top of the first limestone layer (approximately 0.1-0.2 m) was loose weathered, "grey" coarse waste, as noted in Piles 1 and 4; although clasts did not exhibit the precipitate layers. Most of the first limestone layer (0.1 m thick) had been converted to a "dark red brown" hardpan, that when broken came to the surface in cemented blocks. This colour was quantified as very dark red (5R2/6) to very dusky red (10R2/2). The pan was difficult to dig through and was dry; some unaltered limestone was sporadically present under the hardpan which had not been altered as yet. There was no evidence of staining in the coarse waste immediately above the hardpan that would indicate a perched water table.

Plate 25: PERD Pile 3, Compacted, Limestone Amended, November 11-13, 1996.
Pit at top of pile.

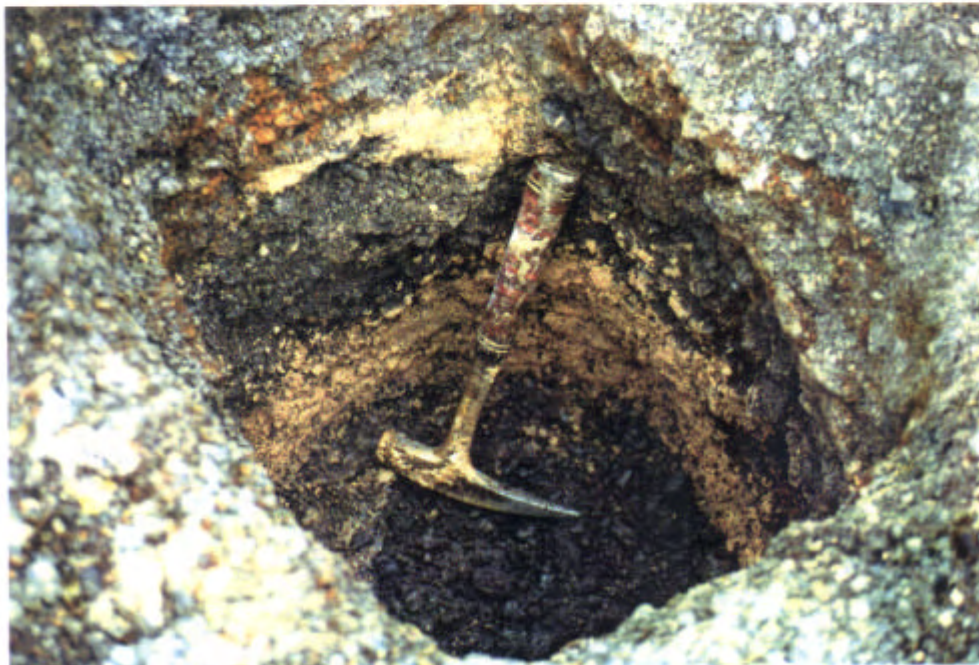
Plate 26: PERD Pile 3, Compacted, Limestone Amended, November 11-13, 1996.
Close-up of pit at top of pile, down to just below second limestone layer.

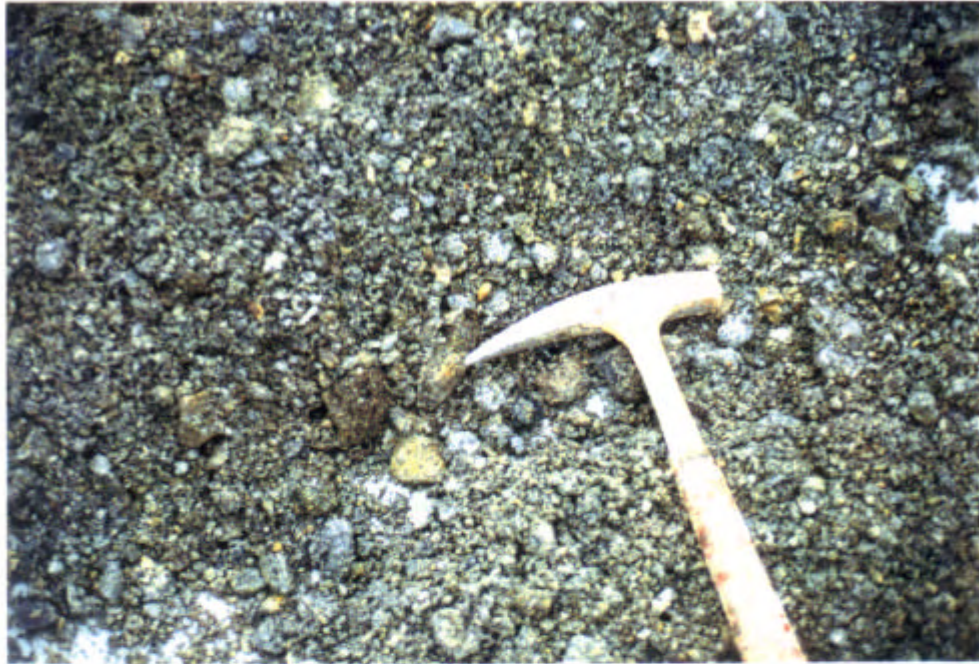
Plate 27: PERD Pile 3, Compacted, Limestone Amended, November 11-13, 1996.
Pit, top of pile. Weathered coarse coal waste above first limestone layer.

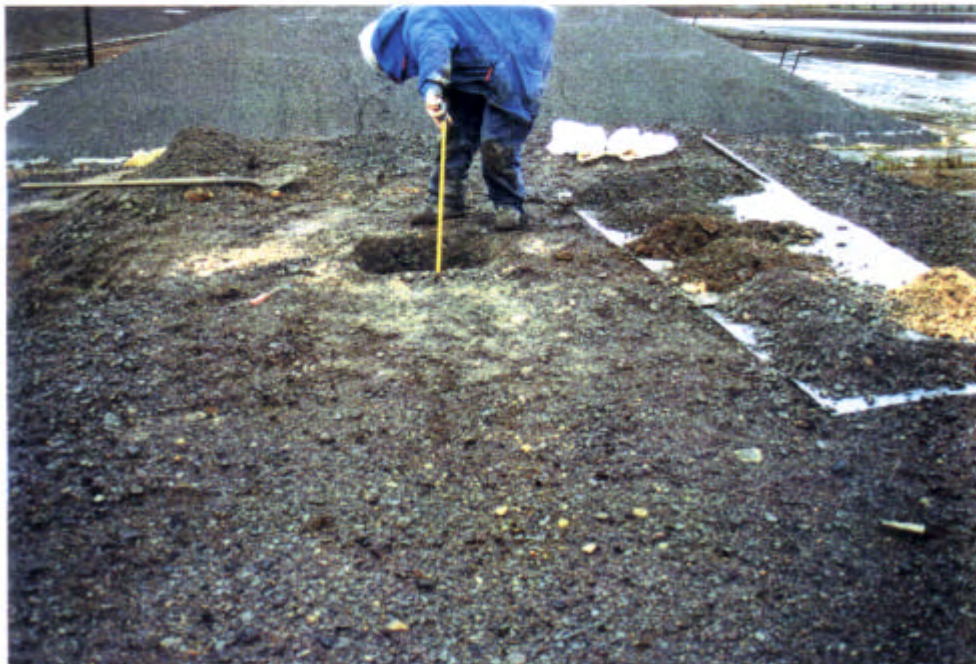
Plate 30: PERD Pile 3, Compacted, Limestone Amended, November 11-13, 1996. Completed excavation of top pit.

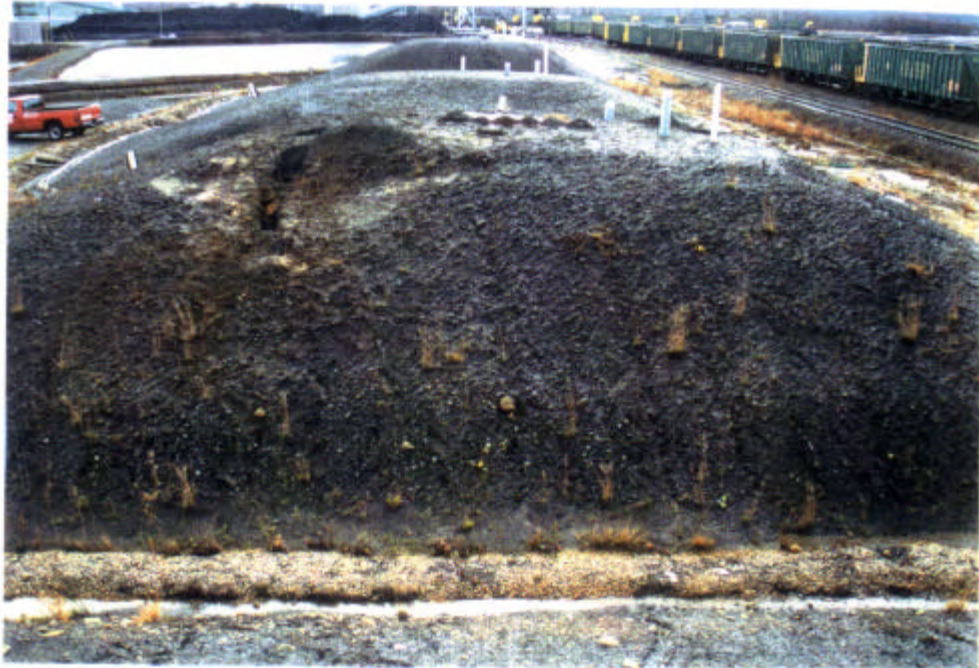
Plate 31: PERD Pile 3, Compacted, Limestone Amended, November 11-13, 1996. trench excavated down E facing slope.

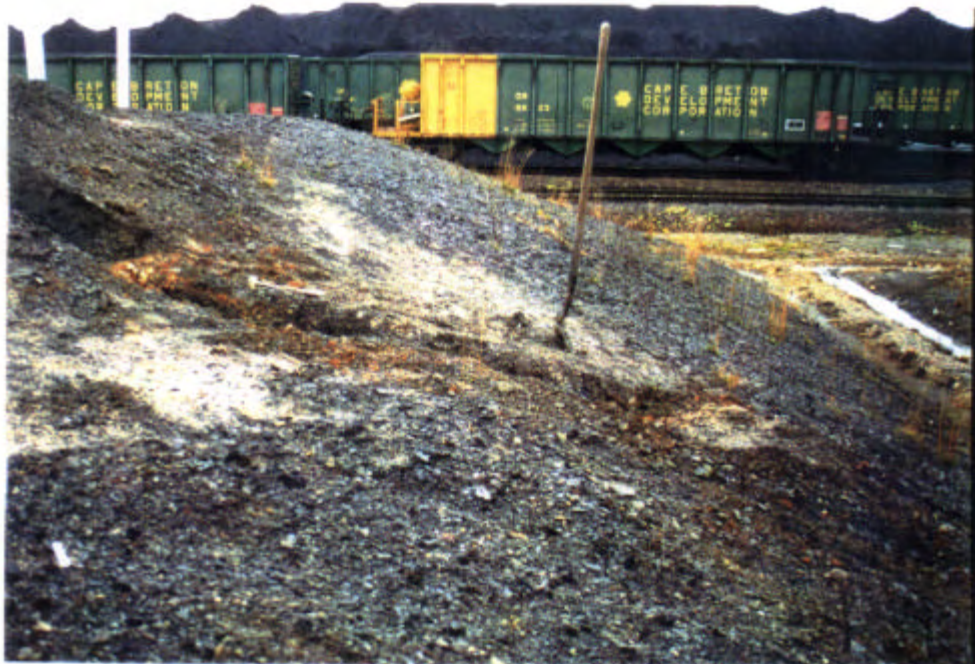
Plate 32: PERD Pile 3, Compacted, Limestone Amended, November 11-13, 1996. trench excavated down E facing slope, side view.

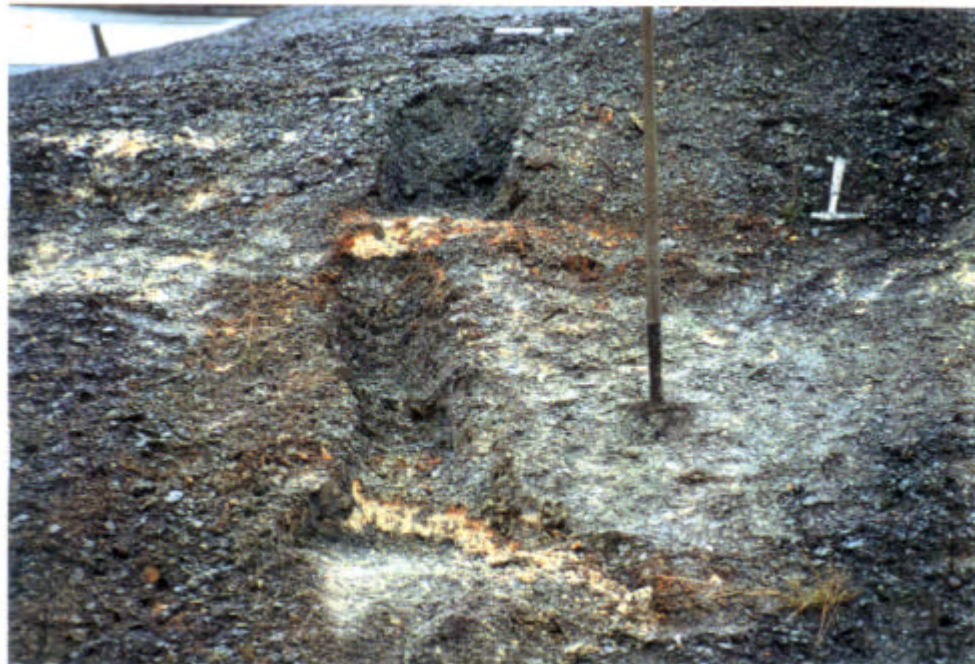
Plate 33: PERD Pile 3, Compacted, Limestone Amended, November 11-13, 1996. Close-up of trench excavated down E facing slope, surface down to second limestone layer.

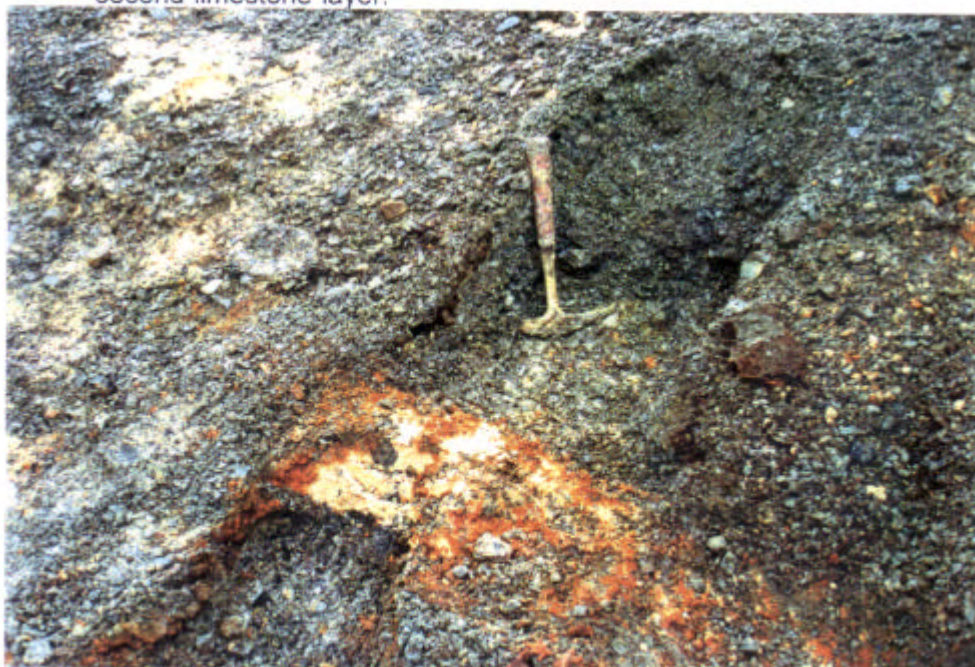
Plate 34: PERD Pile 3, Compacted, Limestone Amended, November 11-13, 1996. Close-up of E facing slope trench where first limestone band meets surface of slope.

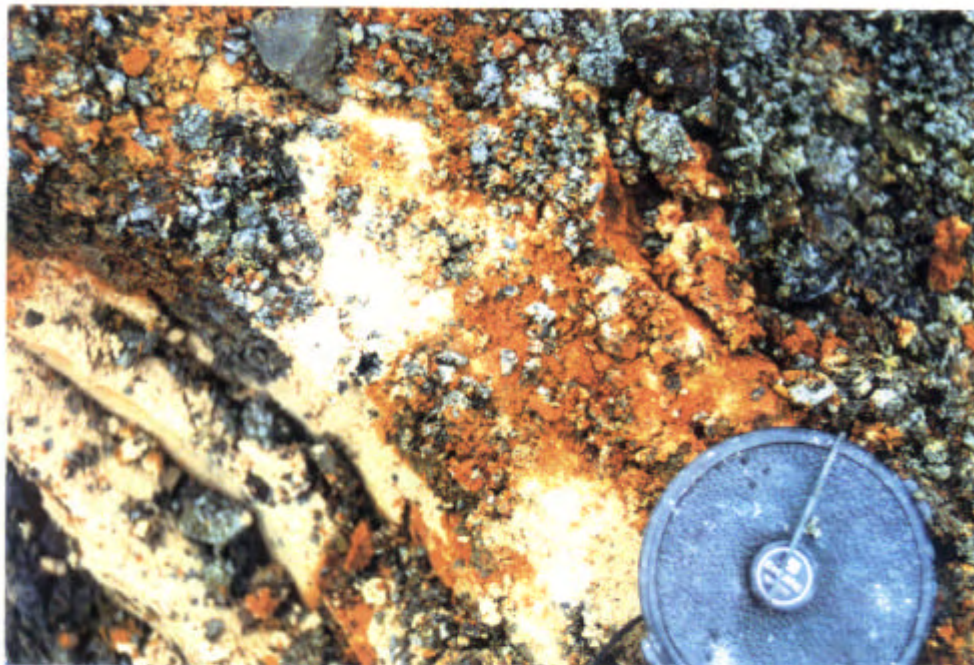
Plate 35: PERD Pile 3, Compacted, Limestone Amended, November 11-13, 1996. Close-up of E facing slope trench where first limestone band meets surface of slope.

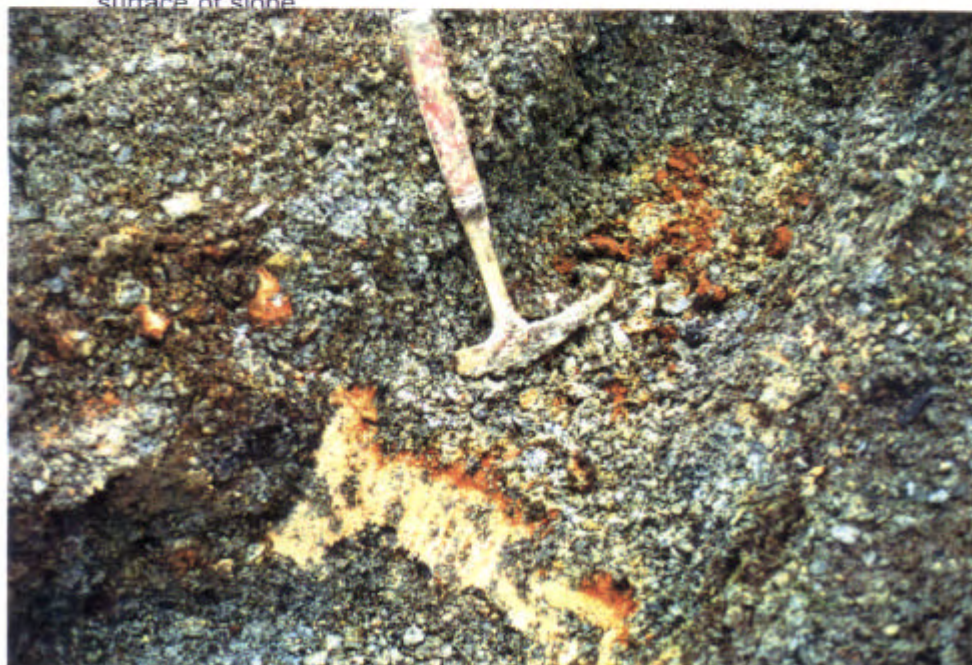
Plate 36: PERD Pile 3, Compacted, Limestone Amended, November 11-13, 1996. Close-up of E facing slope trench where first limestone band meets surface of slope.

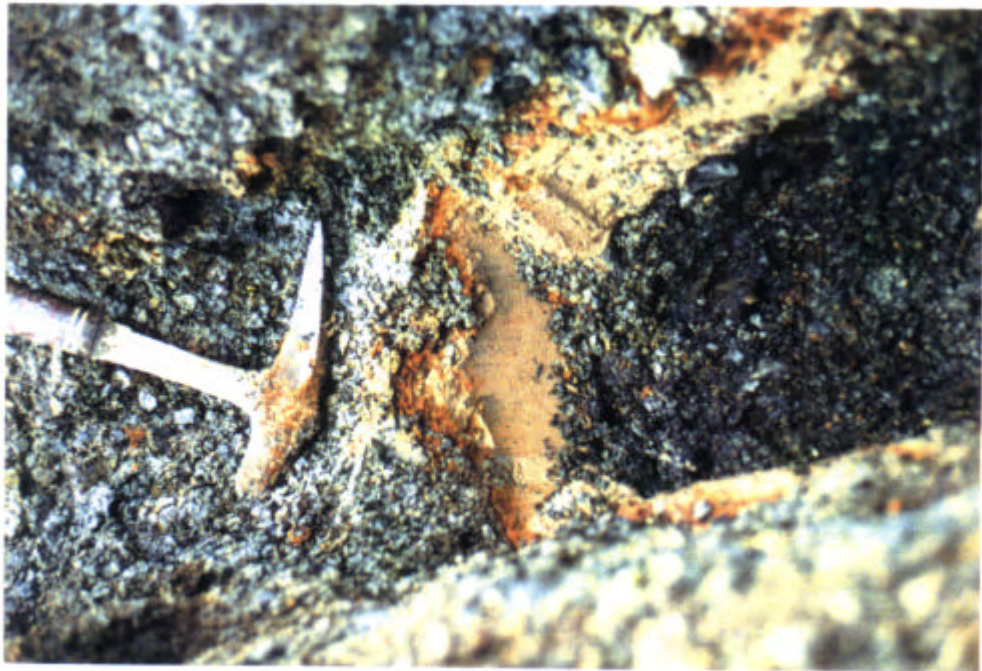
Plate 37: PERD Pile 3, Compacted, Limestone Amended, November 11-13, 1996. Close-up of E facing slope trench where good harpan starts on second limestone layer back in slope.

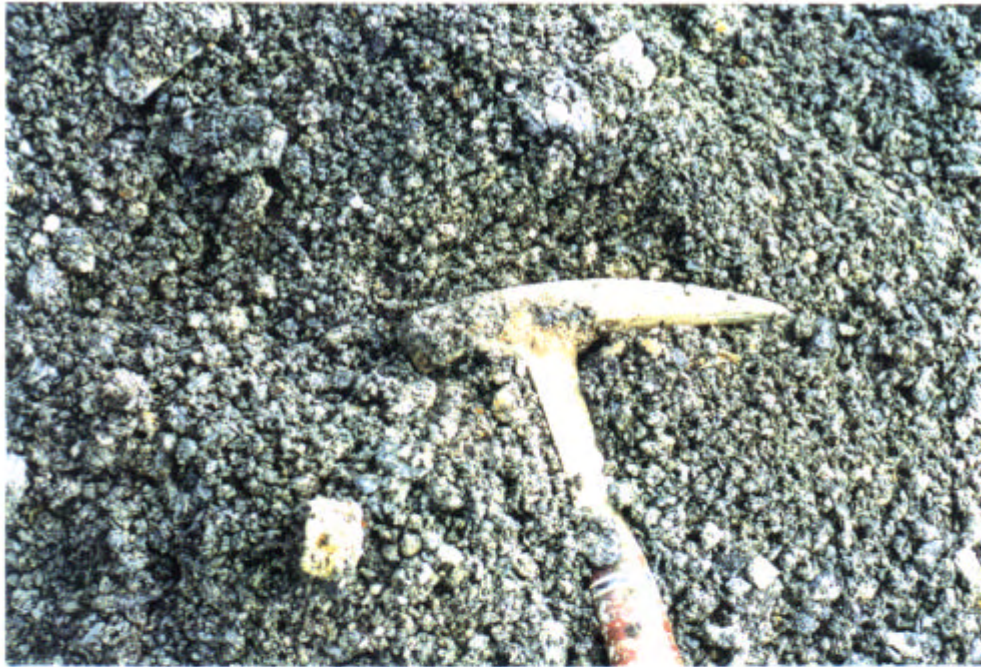
Plate 40: PERD Pile 4, Compacted, No Amendment, November 11-13, 1996. Weathered coarse coal waste in top pit.

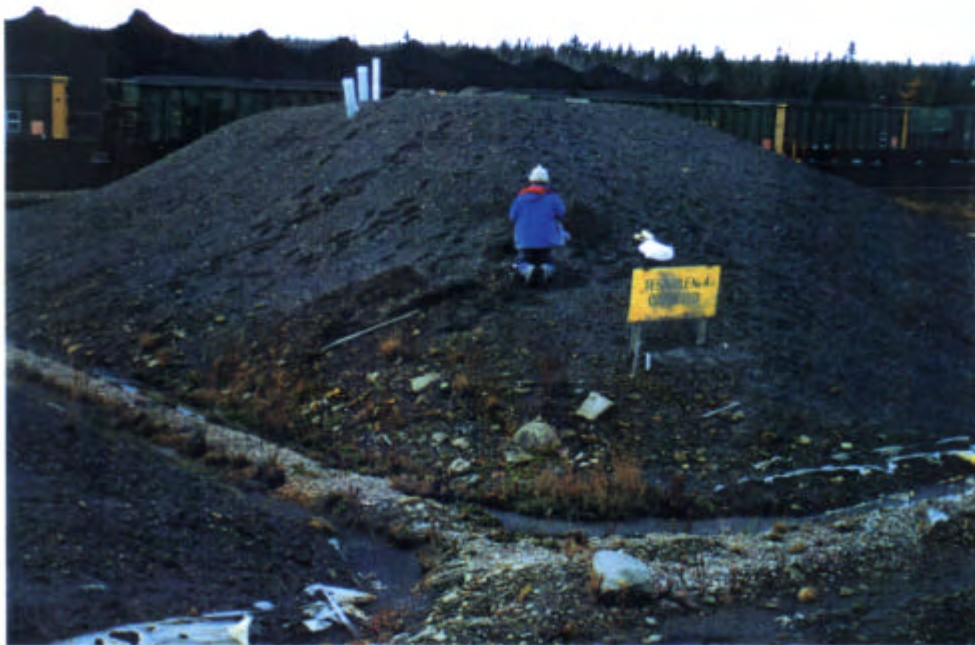
Plate 41: PERD Pile 4, Compacted, No Amendment, November 11-13, 1996. Mid-slope and toe of slope pits on SW corner.
